### **Public Buildings Enhanced Energy Efficiency Program**

### Final Report Investigation Results For Elmer Andersen Human Services Building

Date: 5/31/2012

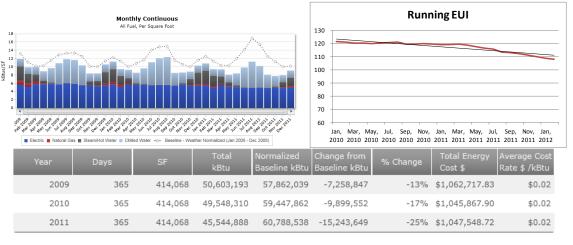
Elmer Andersen Human Services Building Consumption Report Total energy use decreased 11% during the period of the investigation
